Guam SOLID WASTE RECEIVER

Overview of the Guam Solid Waste Receivership

Pursuant to Order of the
United States District Court of Guam

March 6, 2019

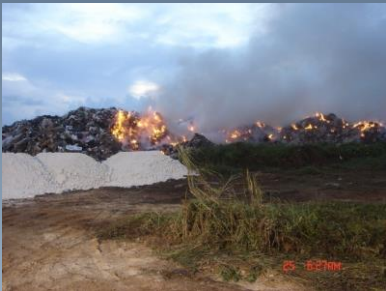
**Ordot Landfill Fire Nov. 2006
(One of many...)**

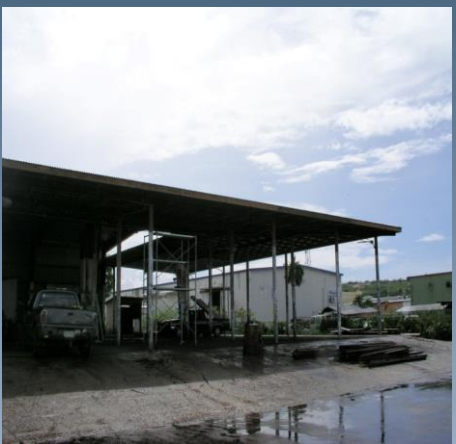
Fleet Maintenance Shop Repaired Missing Roof Replaced

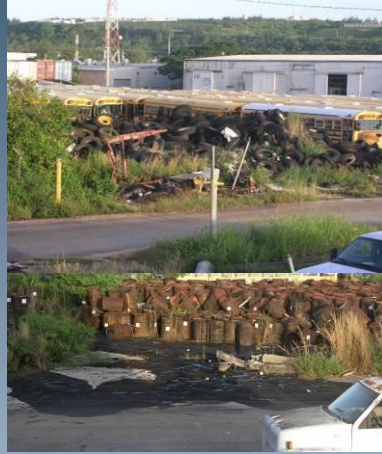
Serious Health Hazards Surround SWMD Building

- Conditions Surrounding GSWA facility:
 - Leaking drums
 - Scrapped cars and school buses
 - Piles of tires
- Conditions hazardous to customers and staff

Court- Ordered Cleanup of DPW Compound

- Significant improvement in the area adjacent to SWMD; abandoned vehicles removed
- Drums being removed; tires slowly being removed
- Receivership provided initial funding for the removal of drums
- Funds reimbursed and deposited to Citibank Trust Account per the Court's Order

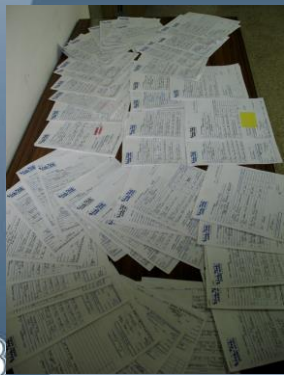
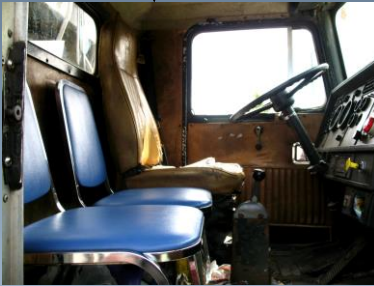
← Mechanics' Purchase Requests to Fix Equipment Left Unprocessed by DPW.
Lack of Parts Lead to Unsafe Conditions.

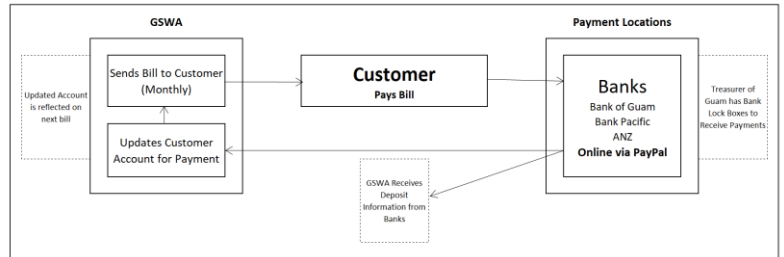
Revised Customer Payment System

graph LR
    subgraph GSWA
        G1[Sends Bill to Customer Monthly]
        G2[Updates Customer Account for Payment]
    end
    subgraph Customer
        C[Customer Pays Bill]
    end
    subgraph PaymentLocations
        B[Bank of Guam  
Bank Pacific ANZ  
Online via PayPal]
    end
    G1 --> C
    C --> B
    B --> G3[GSWA Receives Deposit Information from Banks]
    G3 --> G2
    G2 --> G1
    B --- B1[Updated Account is reflected on next bill]
    B --- B2[Treasurer of Guam has Bank Lock Boxes to Receive Payments]

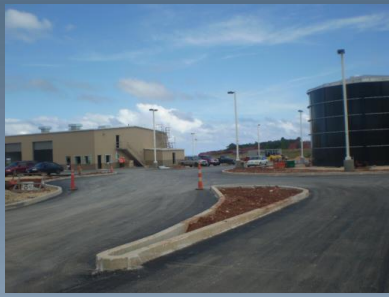
Layon Landfill nearing completion

- Construction of Layon Landfill included the access road and utilities
- The entrance facilities for the Landfill
- Landfill cells 1 and 2
- Construction must be completed before Ordot Dump runs out of space

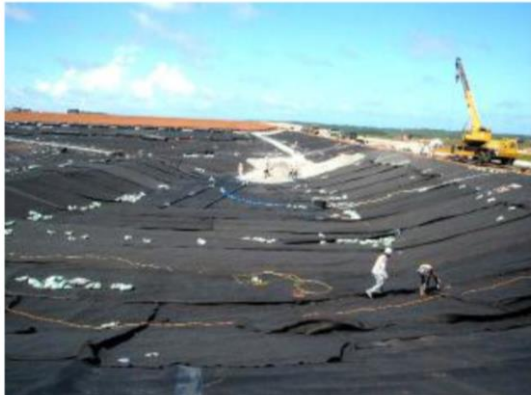
Installation of liner in Cell 1.

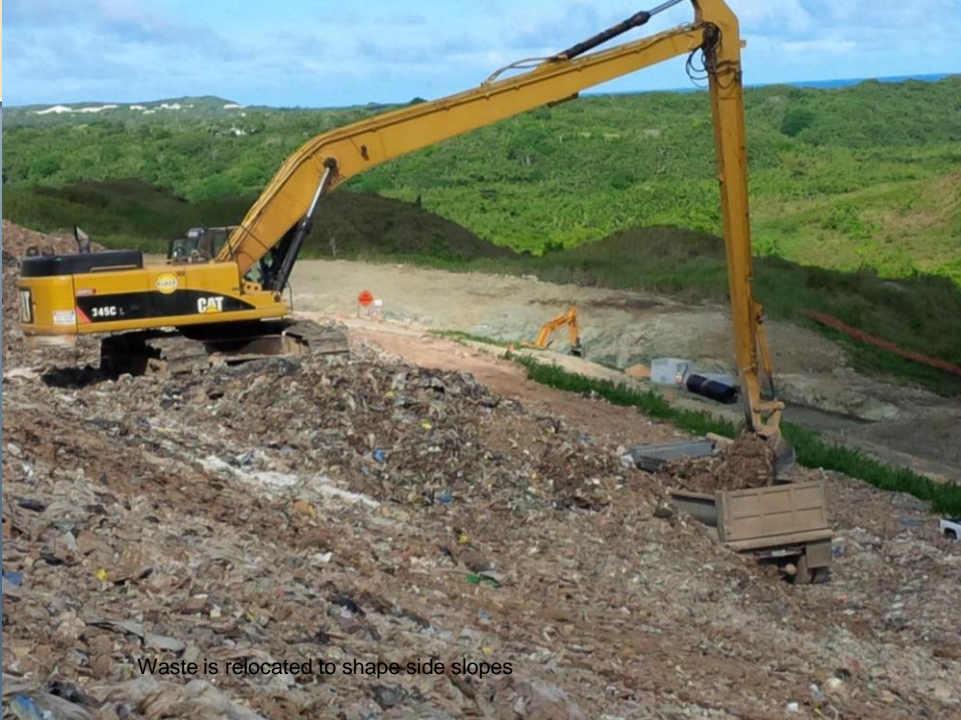
Waste is relocated to shape side slopes

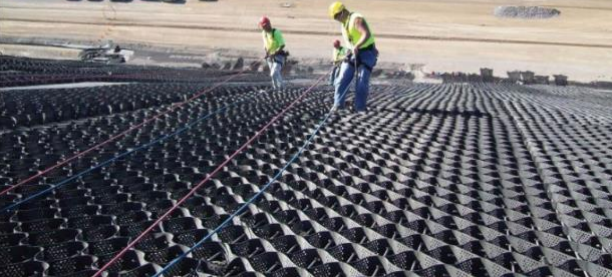
Example of geocell on sideslope before fill placement

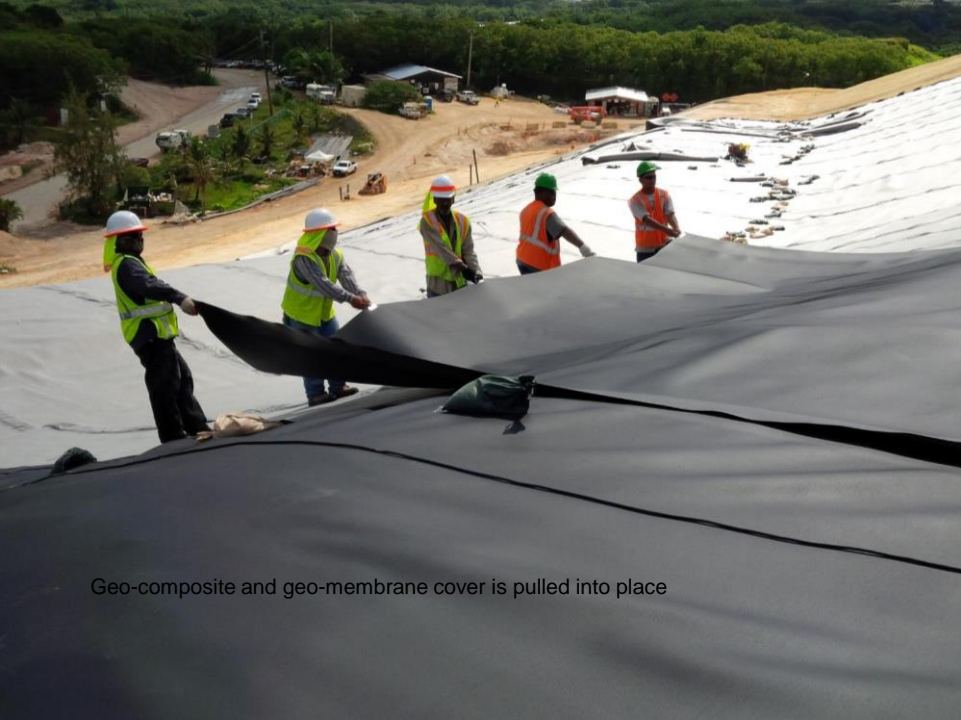
Geo-composite and geo-membrane cover is pulled into place

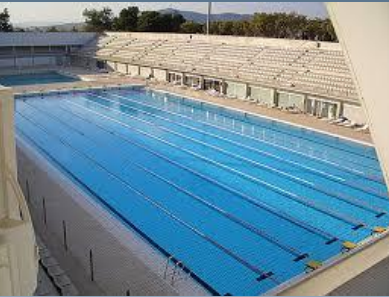
More than **34.4 million gallons of leachate has been diverted from Guam’s Groundwater and the Lonfit River¹**. This amount of leachate could fill about 51 Olympic sized swimming pools.

¹ The leachate is transported for treatment to the Hagatna Waste Water Treatment Plant via the sewer line constructed in Dero Road.
